Main landing gear wheel failure involving a Boeing 737, ZK-ZQB

Sydney Airport N.S.W. 10 June 2014

ATSB Transport Safety Report
Aviation Occurrence Investigation
AO-2014-109
Final – 10 June 2015

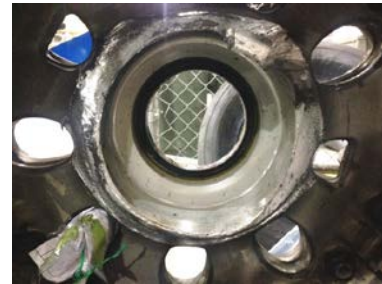
Inboard wheel half remnant

On 10 June 2014, a Boeing 737 aircraft, registered ZK-ZQB and operated by Jetconnect Limited landed at Sydney Airport, New South Wales. During taxiing, the crew felt a slight shuddering from around the main landing gear; they also observed that they required a higher-than-normal thrust to taxi the aircraft. At the crew’s request, personnel in the Air Traffic Control tower and a passing aircraft observed ZK-ZQB, but did not see anything abnormal. The crew then requested that Rescue and Fire Fighting Services conduct a close-up inspection. They advised the crew that pieces of metal had fallen onto the runway and that the right, outer main wheel was leaning over. After parking the aircraft, an examination by Licenced Aircraft Maintenance Engineers confirmed that the inboard wheel half-hub had fractured into several pieces and that the wheel bearings were intact (Inset figure).

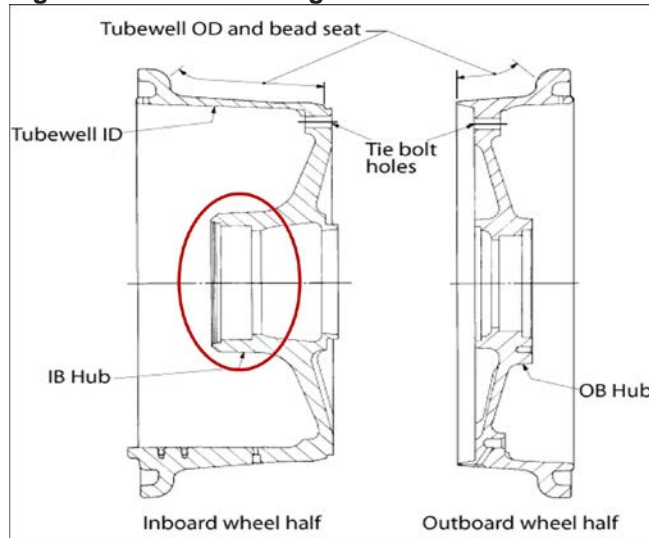
Figure 1: Schematic diagram of wheel hub with the failure location circled

The wheel hub consisted of an inboard and outboard section (Figure 1). The inboard wheel half on ZK-ZQB was part number 2612462 and serial number B3902.

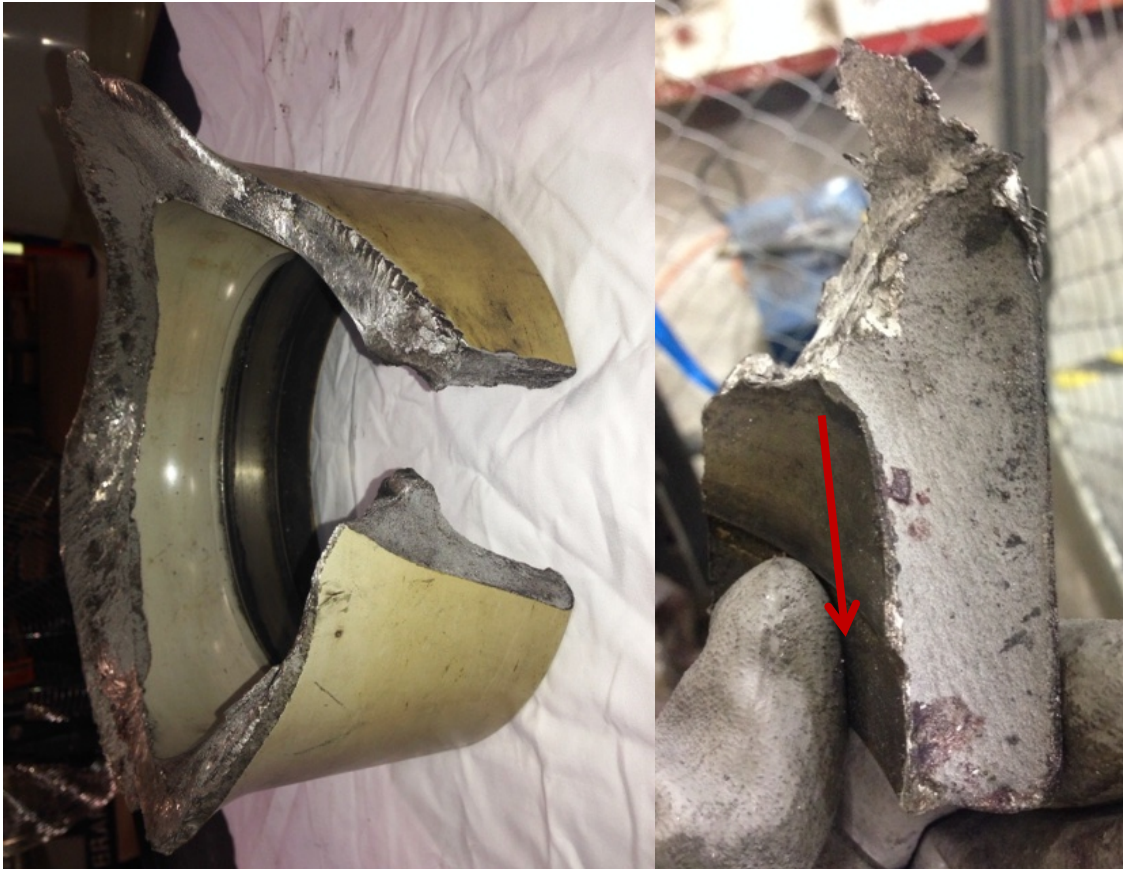
Figures 2a and b: Fractured hub from the inboard wheel half and chevrons leading from the damaged, radius-area origin; the arrow shows the direction of crack growth from that area

After removal of the bearing cup, the aircraft operator inspected the bore and reported that there was no sign of bearing cup rotation. A visual inspection of the fracture surfaces was then performed by the operator’s maintenance organisation that indicated the origin of the failure to most likely be in the area of the bearing bore radius (Figures 2a and b). However, that area had been damaged, following the final fracture. From the point of origin, a series of cracks grew both axially (Figure 2b) and circumferentially around the inboard hub (Figure 3). In the axial direction, chevrons on the fracture surface radiated from the radius area. Circumferential crack growth occurred partly by joining a series of smaller, tertiary cracks on the hub’s outer diameter. The surfaces of that circumferential crack showed the joining process as a series of ratchet marks. This earlier part of that fracture surface was burnished as the two faces of the crack had rubbed

The wheel manufacturer also examined the failure. They concluded it was likely that the fatigue crack initiated in the stress-concentrated, transition region between the bearing bore wall and the circumferential radius. Ultrasonic testing of this area detected possible small fatigue cracks or origins.

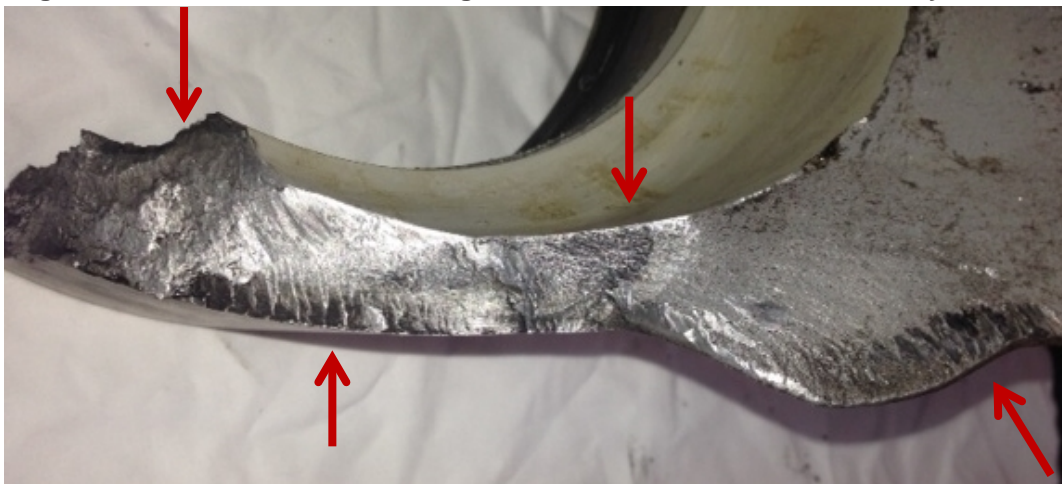
Figure 3: Secondary, circumferential crack showing, from left to right, the damaged origin area, ratchet marks/burnishing, beach marks and ultimate failure by overload

together over a period of time, obliterating some detail. The crack then became a singular front with beach marks, an indicator of fatigue cracking. The area of ultimate failure changed from fatigue to the more rapid, overload mode.

The ATSB was advised by the aircraft operator that they are upgrading their fleet with carbon brakes from a different manufacturer. As a result, all current main wheel assemblies will be replaced with wheels from that manufacturer; hence, those wheels will have a different part number. The modification program of fitment with new wheels and brakes commenced in February 2015 and will be completed by the end of May 2015.
