Report 09-004

Britten Norman BN2A-Mk III Trislander

ZK-LOU

loss of engine propeller assembly

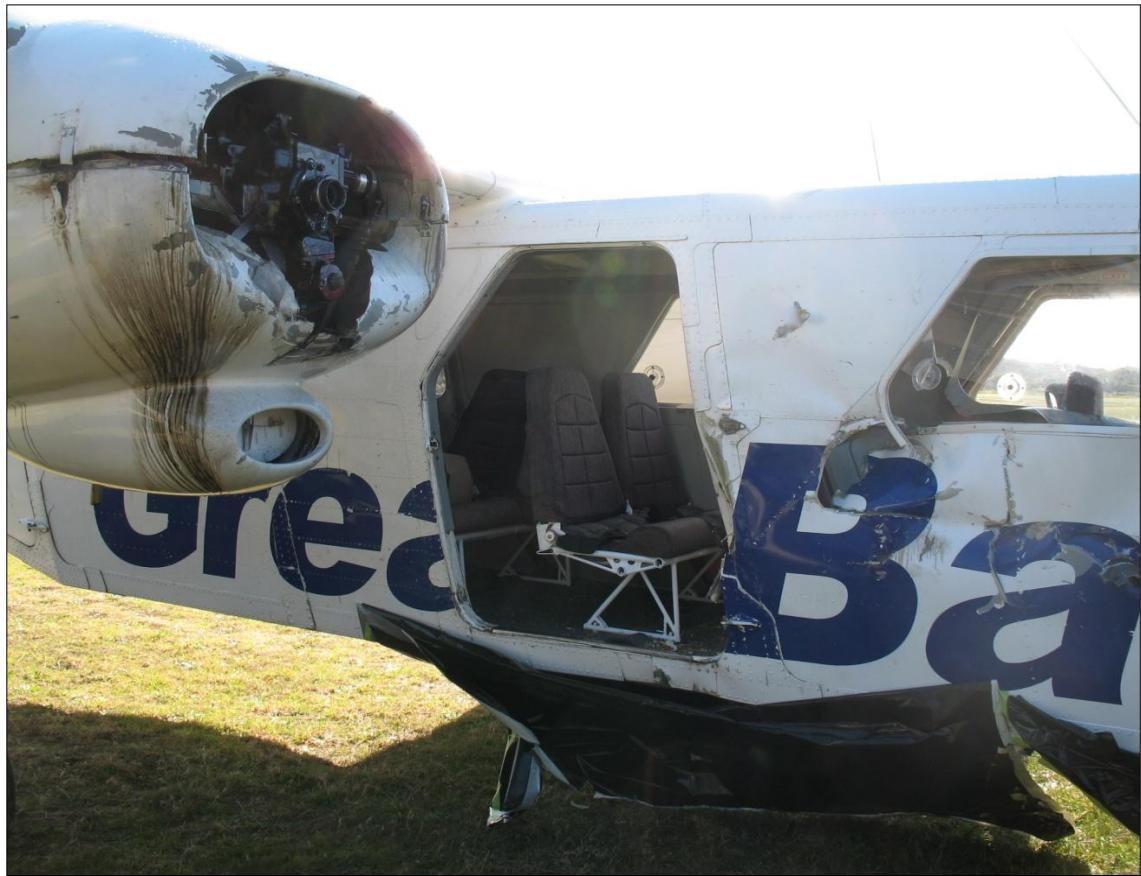
- 1.1.9 After landing, the pilot stopped the aeroplane on the runway and checked on the passengers before taxiing to the apron. At the apron he shut down the other engines and helped the passengers to the terminal, where they were offered drinks. The company chief executive, who lived locally, and a local doctor attended to the passengers. Three of the passengers received some minor abrasions and scrapes from shattered Perspex and broken interior lining when the propeller struck the side of the fuselage (see Figures 2 and 3).

- 1.2.1 The right engine crankshaft flange that attached to the propeller hub had fractured through lightening holes in the flange. The complete propeller assembly had released from the fractured crankshaft flange and struck the side of the fuselage adjacent to the engine, substantially damaging the fuselage. The fuselage skin had been penetrated in places and a passenger window Perspex had shattered, but nobody was seated in that passenger row. Immediately behind the window the propeller assembly struck a passenger door next to which a passenger had been seated. The door hinges were damaged and the door fell from the aeroplane, leaving a large hole in the side of the fuselage by the passenger (see Figure 2).
- 1.2.2 No part of the propeller assembly entered the cabin, but the cabin interior lining and insulation were damaged and pushed inwards onto some of the passengers (see Figure 3).

Figure 2
ZK-LOU right side showing damage and missing propeller

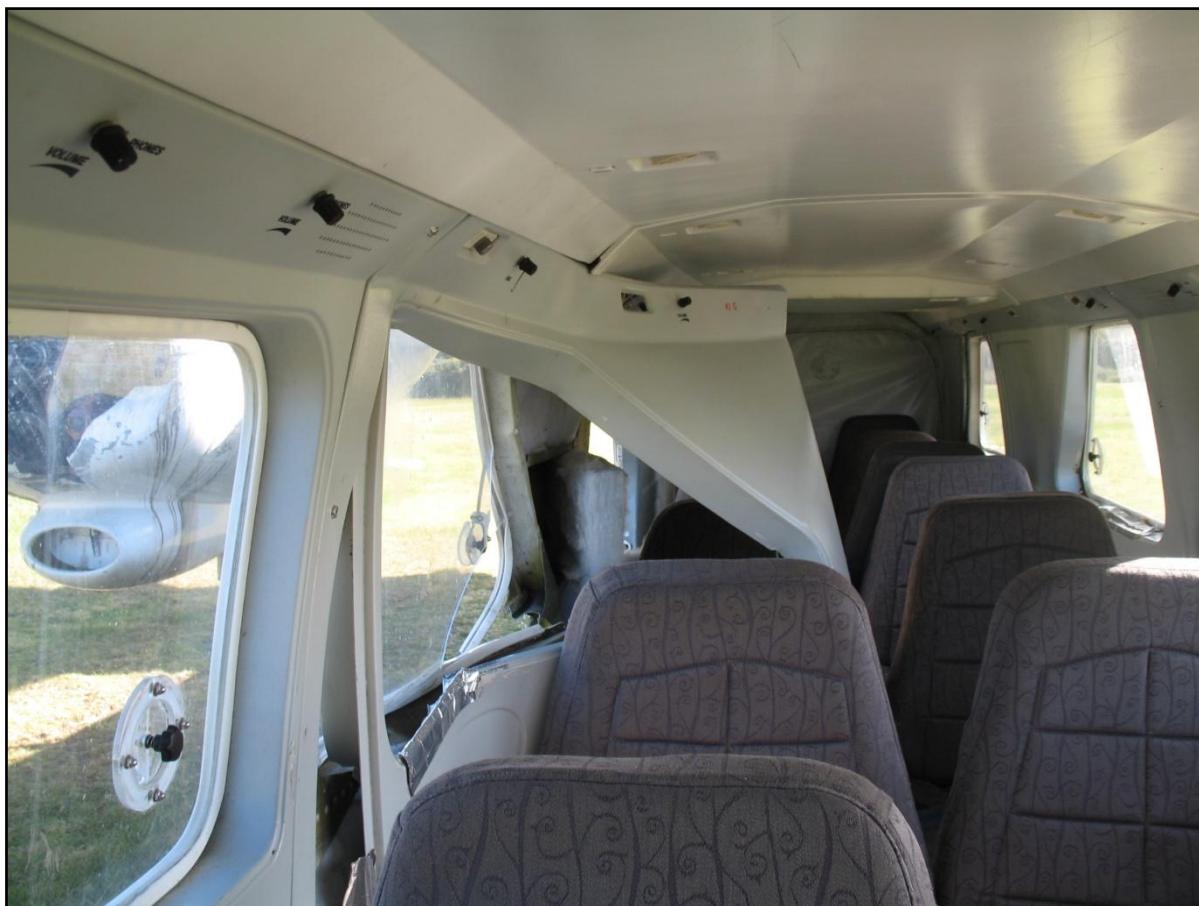
Figure 3
ZK-LOU interior showing cabin lining damage

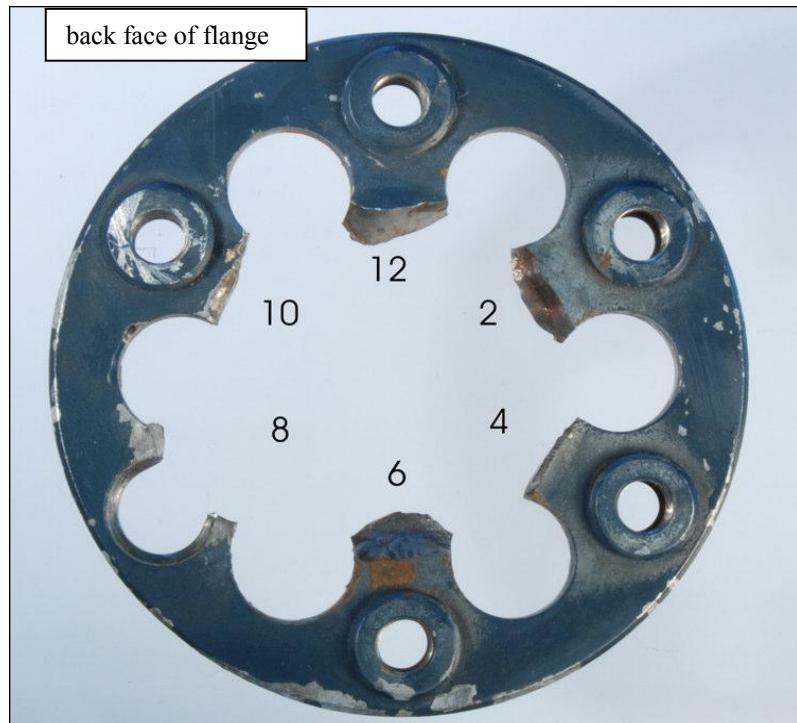
The flange had fractured through the spoke web sections separating the 6 lightening holes [see Figure 5]. Five of the webs had fractured at or near the fillet between the flange and the crankshaft. The rear face of the flange retained its paint coating but some corrosion was evident on the webs near and in some of the lightening holes. The corrosion, visually evident as patches of rust, had penetrated the cadmium protective plating beneath the paint and affected the underlying steel surface. Close inspection indicated that the corrosion had pitted the steel in places. The forward face of the flange was also rust-stained in isolated areas. Cadmium plate covered much of the surface but it had been abraded and fretted locally. Traces of paint were also present in a few places on the front surface. The crankshaft stub section projecting forward from the flange was extensively and irregularly fretted and its rim was bent inwards across one sector. This deformation was likely to have occurred as the propeller pitched and rotated off the flange in the final stage of the failure sequence.

Figure 5
Broken crankshaft flange that was attached to the right engine propeller hub
(DTA 2009)

Inspection showed that 5 of the 6 fracture surfaces had clear signs that metal fatigue had played a critical part in their failure. The remaining web element that also went through a bolt hole [see position 8 in Figures 5 and 6] had failed by ductile shear which was likely to have occurred during the final stages of propeller separation.

Two of the fatigue fractures, at Positions 6 and 2 [see Figures 5 and 6] appeared relatively old, being discoloured and fretted to the point of having lost all microscopic surface detail. However, crack surface beach-markings indicated that the cracks had initiated on the rear face of the flange, at the fillet between the flange and shaft. Both cracks had grown forward and inwards towards the fillet at the front of the flange. The fracture at Position 6 had initiated in a region of extensive corrosion pitting. Multiple corrosion pits up to 0.2mm in size were found in this area. Some corrosion was also evident at the initiation point of the fracture in the Position 2 web.

Two other fractures, at Positions 4 and 10, had received severe surface damage during the final phases of flange breakup. Both had some signs of fatigue crack development from the rear face of the flange but one of them (at Position 10) showed extensive crack growth rearwards from the forward face towards the top of the fillet blend on the rear face. The fracture in the web at Position 4 had a similar configuration.

The fatigue crack surfaces at Position 12 were relatively fresh. The fractures were only locally fretted and were largely uncorroded. Clearly-defined beach marks were evident in places. These markings showed that the crack had initiated at the rear of the flange from the web corner loaded in tension by crankshaft torque. This fracture also ran inwards towards the front web/shaft fillet.

The corrosion pitting damage on rear faces of some of the webs most likely triggered crack initiation. The corrosion had evidently occurred after local failure of the paint coating, followed by penetration of the cadmium plate covering the surface. The observed corrosion pitting would have compromised the fatigue resistance of this highly loaded area of the crankshaft.

- 2.7 Because corrosion can lead to cracking, as demonstrated in this case, any corrosion that is found around crankshaft flanges should be removed and the area specifically checked for cracking and protected as advised in the Continuing Airworthiness Notice.

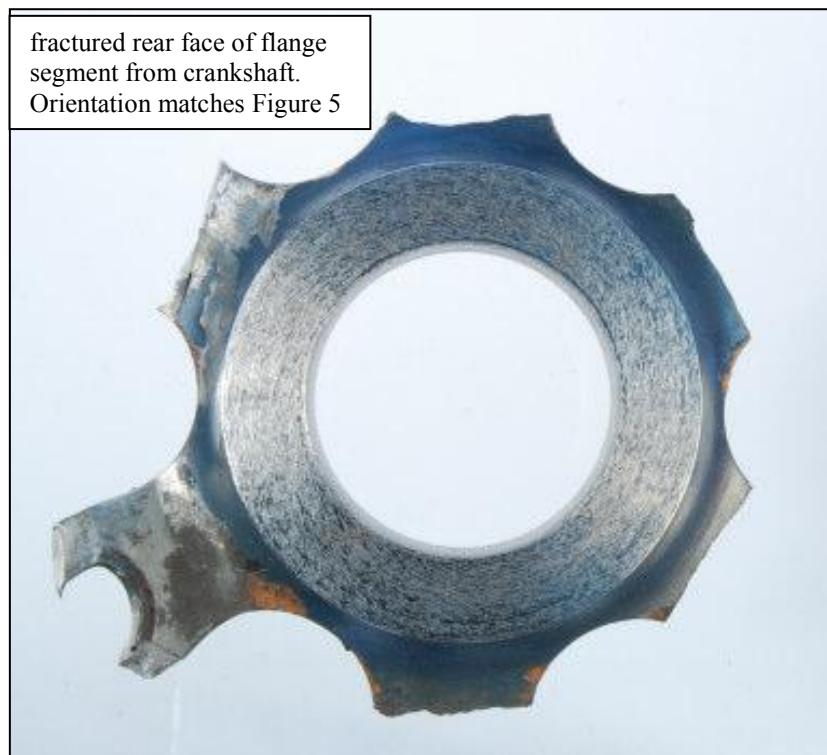
Figure 6
Fractured rear face of flange centre (machined off the crankshaft)
(DTA 2009)

All the cracked webs showed signs of defect initiation on the rear of the flange at or near the point where the fillet intersected the flange surface. Three of the defects had grown forward and inwards to intersect the front fillet on the flange while the two other cracks had cut across the web.

The form of the oldest cracks indicated that the crankshaft flange had been subjected to loads with a significant fore-aft bending component which induced cracking primarily from the rear face of the flange. The configuration of the cracks also indicated that they were caused by high cycle fatigue from relatively high frequency load fluctuations rather than low cycle fatigue from engine start/max power/stop cycles.
