# ACCIDENT INVESTIGATION REPORT

**CANADIAN PACIFIC AIRLINES DC8-63  
AIRCRAFT CF-CPO  
and  
TRANS-AUSTRALIA AIRLINES BOEING  
727 AIRCRAFT VH-TJA  
AT SYDNEY (KINGSFORD SMITH) AIRPORT  
NEW SOUTH WALES ON 29 JANUARY, 1971**

Prepared by:  
Air Safety Investigation Branch Melbourne

August, 1971

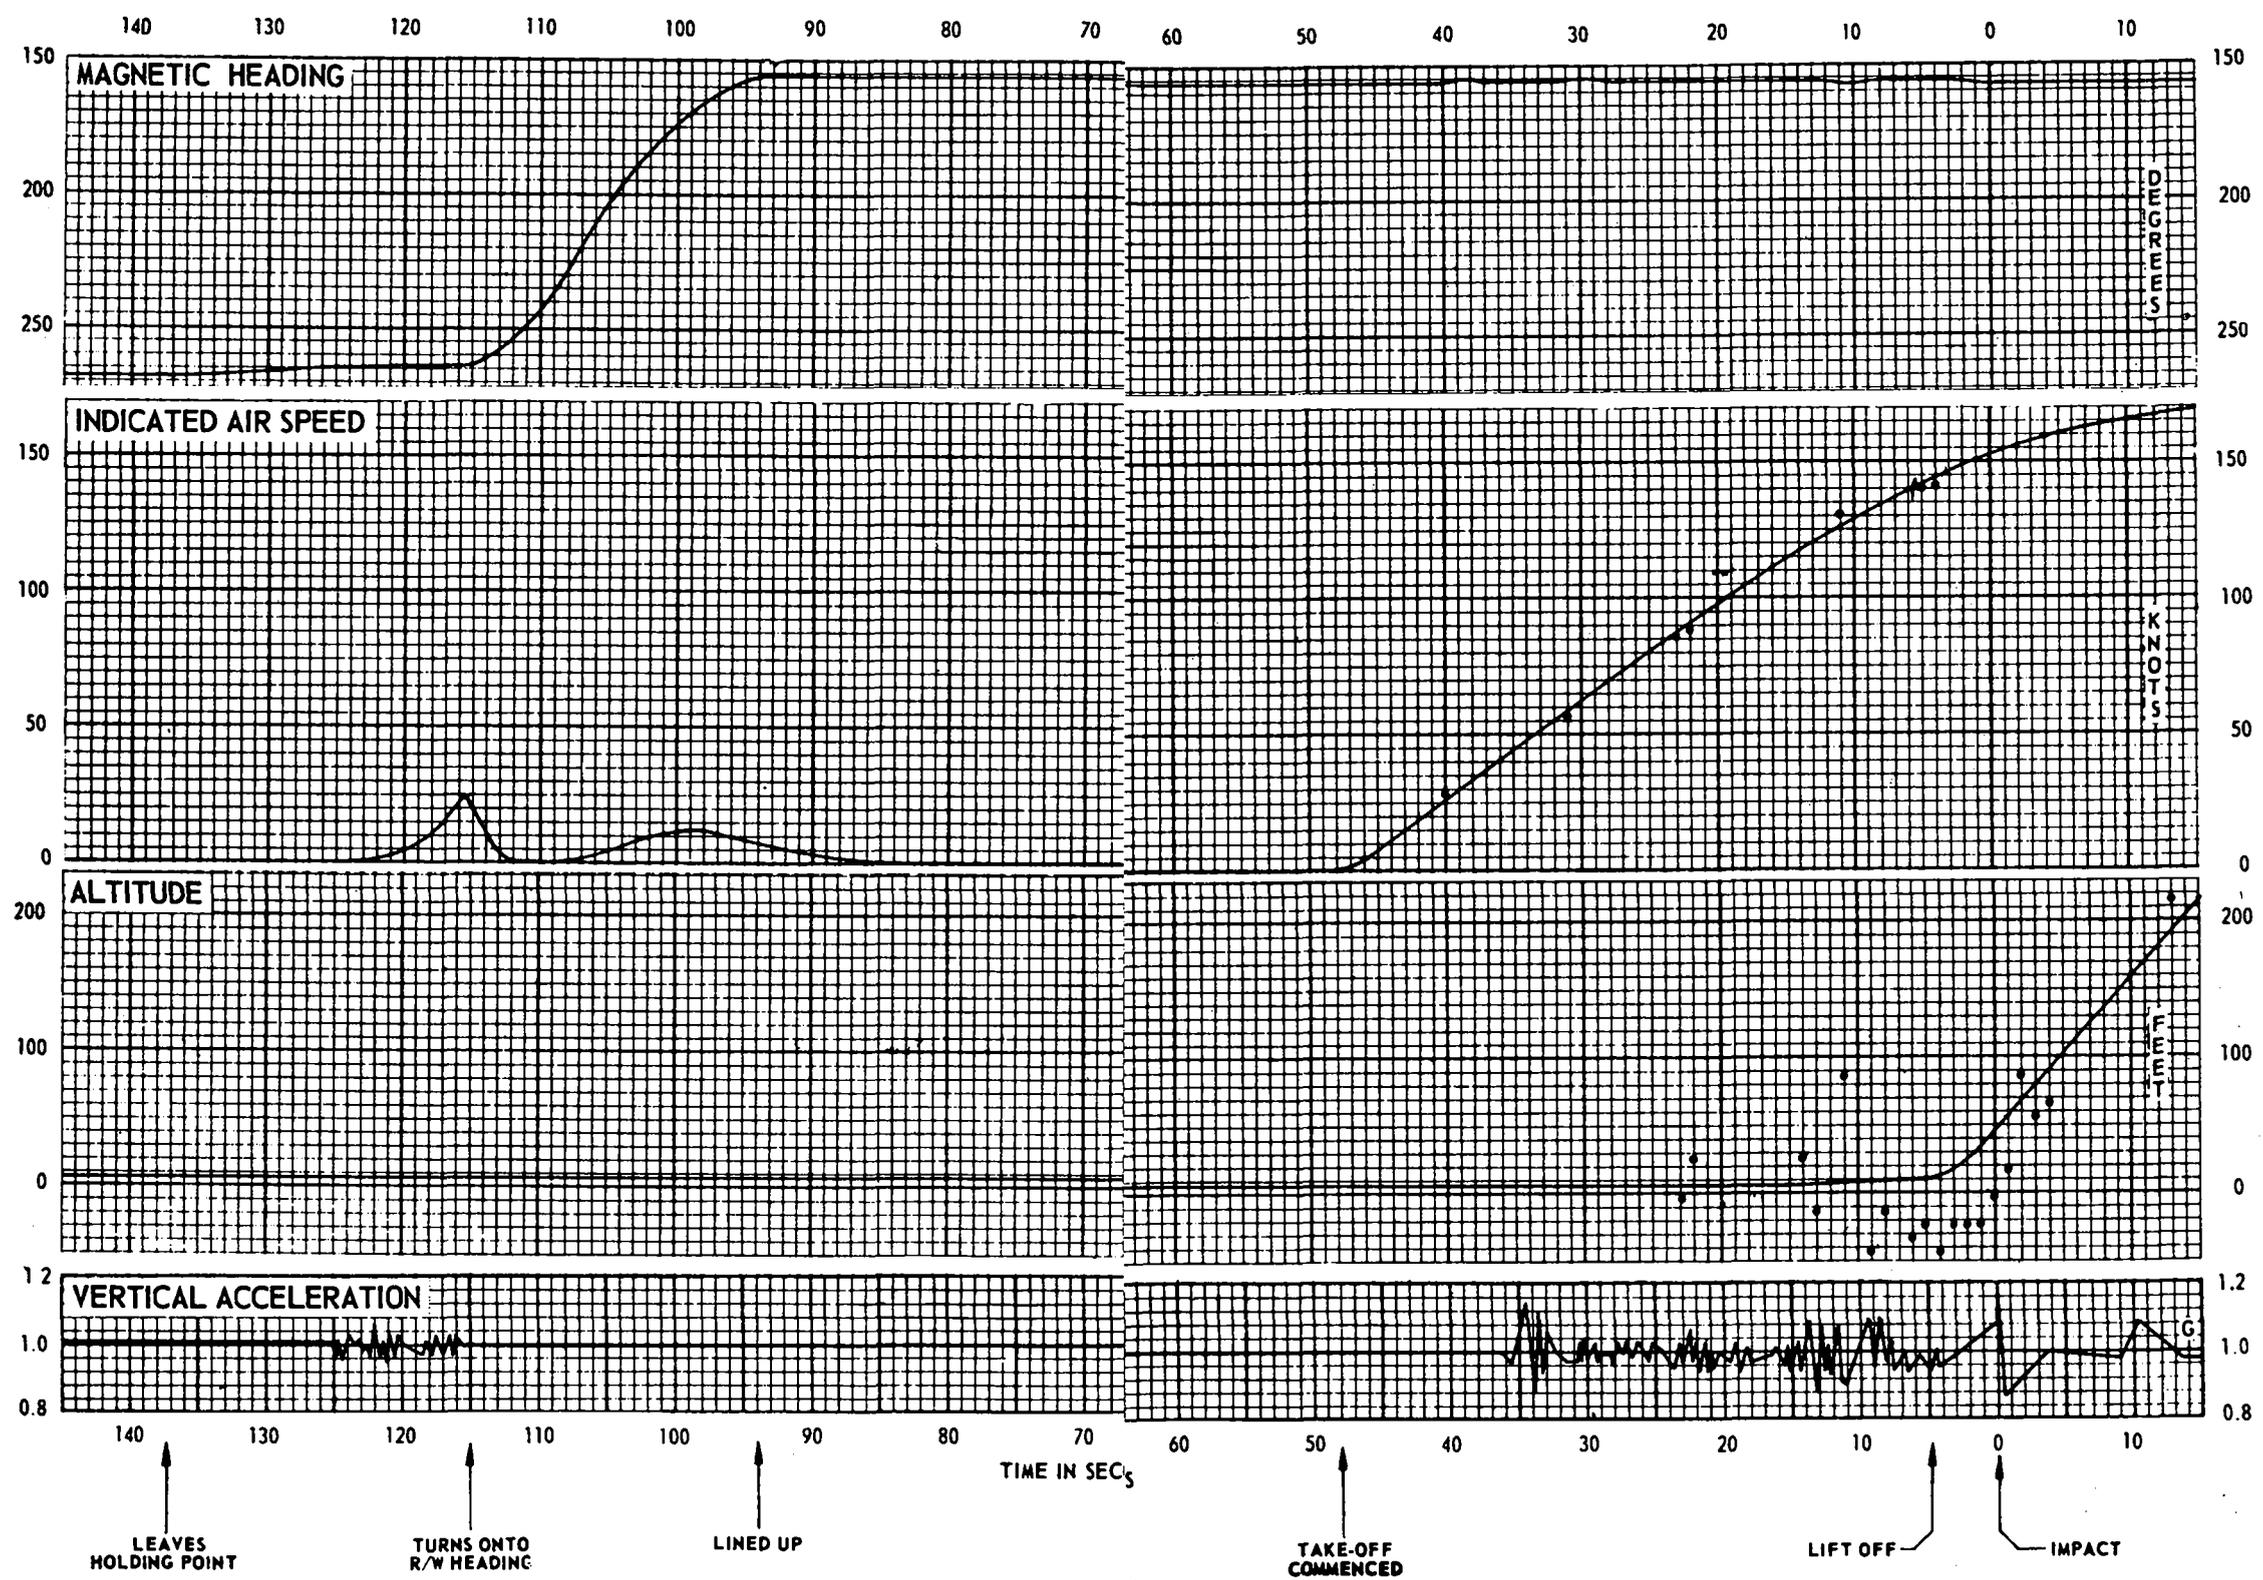
Finally, it is assumed in this chart that the abrupt "G" trace deviation at 152.5 knots observed in the VH-TJA flight data record shortly after the aircraft became airborne in fact defines the impact as is suggested in Appendix C. It is obvious that the collision must have occurred very close to this time and, in the absence of any recourse to the cockpit audio record, this assumption seems entirely reasonable.

Recorded Flight Data - V<sub>H</sub>JA, during taxi and take-off.

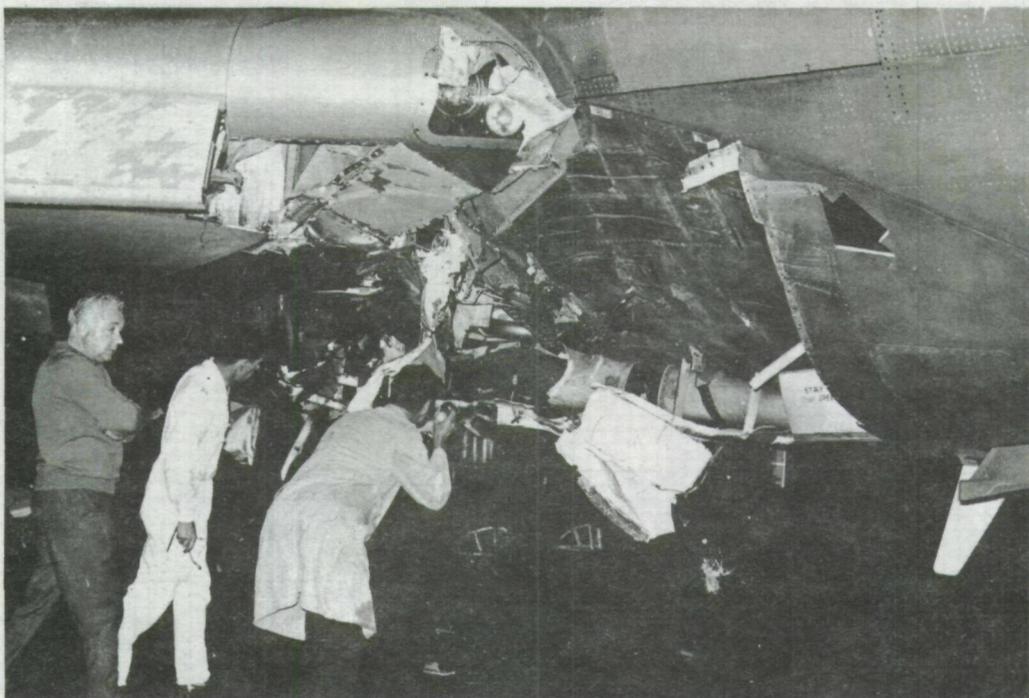
The first contact between the two aircraft was sustained by VH-TJA on the starboard main wheel bay fairing approximately 50 inches forward of and 20 inches below the wing leading edge. The area of damage widened as it progressed rearwards and extended down to near the fuselage centreline and upward and outward along the wing under-surface to the leading edge flap (see Appendix D, Fig. 1).

FIG. 1 Damage to VH-TJA in forward wing root area on starboard side. The arrow indicates the point of first contact.

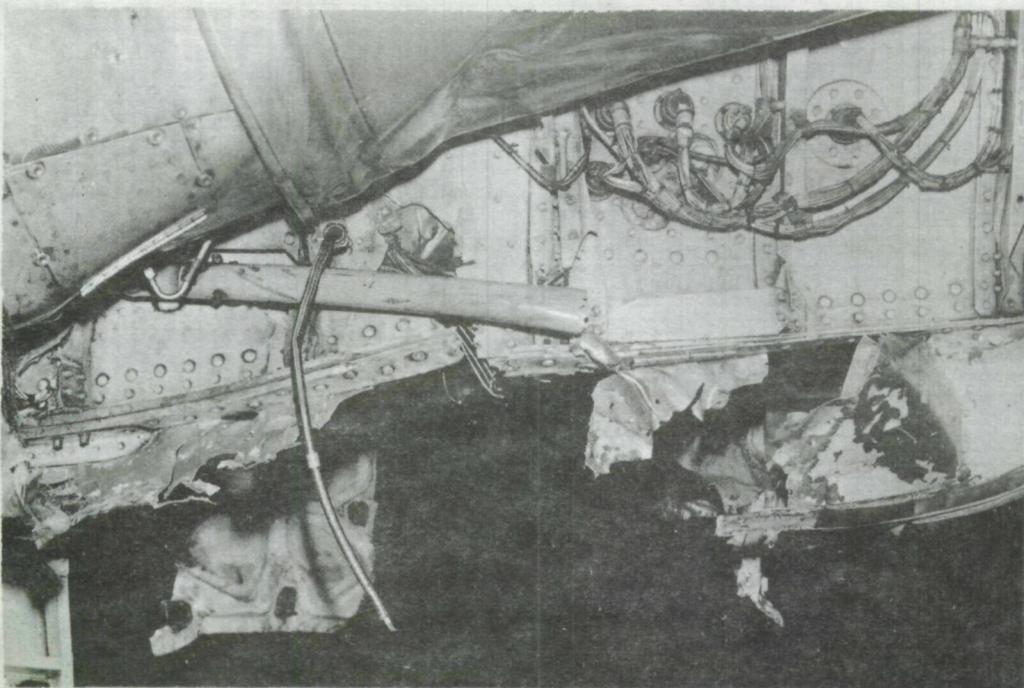
The lower portion of the starboard wheel bay forward bulkhead received a heavy rearward blow. The impact severed the lower frames and penetrated vertically into the diaphragm to a depth of approximately 15 inches (see Appendix D, Fig. 2). The metal air-conditioning duct located on the forward face of the diaphragm was crushed and punctured and some wires in an adjacent electrical loom were severed.

FIG. 2 View from within starboard wheel bay of VH-TJA, showing damage sustained by forward bulkhead.

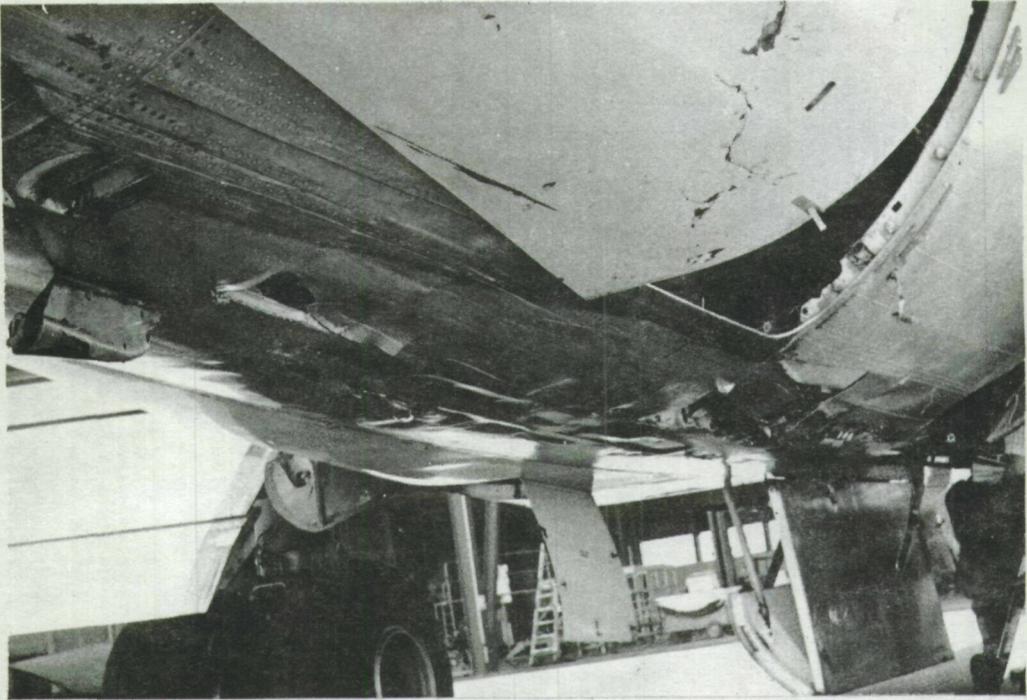
A series of score marks and lower fuselage skin punctures extended rearward and inboard from the point of heavy impact on the wheel bay rear bulkhead to the tail bumper (see Appendix D, Fig. 3). This bumper had been broken from its hinge and shock absorbing strut. The failure was caused by impact on the bumper frame in a rearward direction consistent with it having struck the DC8 fin.

FIG. 3 Underside of fuselage of VH-TJA showing score marks and punctures between starboard wheel bay area and tail bumper.

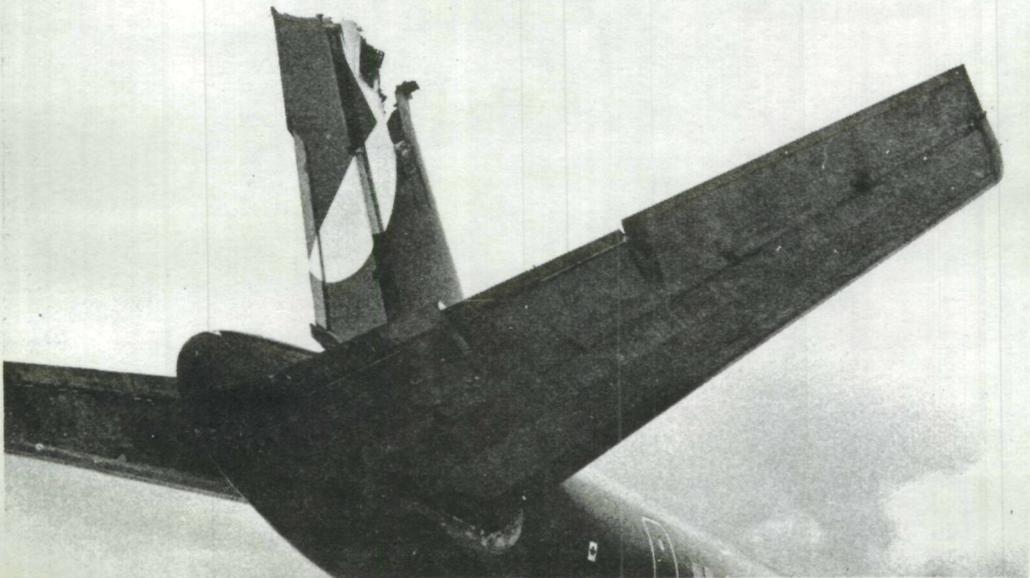
The extent of damage to this aircraft was confined to the fin, rudder, starboard tailplane and elevator. The fin was severed along an approximately horizontal plane reducing its vertical height by some eight feet six inches (see Appendix D, Fig. 4). The fracture surfaces along this plane all showed scratches and bending consistent with the structure above the separation line having received a blow from the forward left side of the aircraft.

The rudder was severed immediately above the centre hinge in a chord-wise direction. The direction of failure was consistent with there being a substantial right rudder deflection at the time of the impact.

FIG. 4 Damage sustained by tail fin and rudder of CF-CPQ.

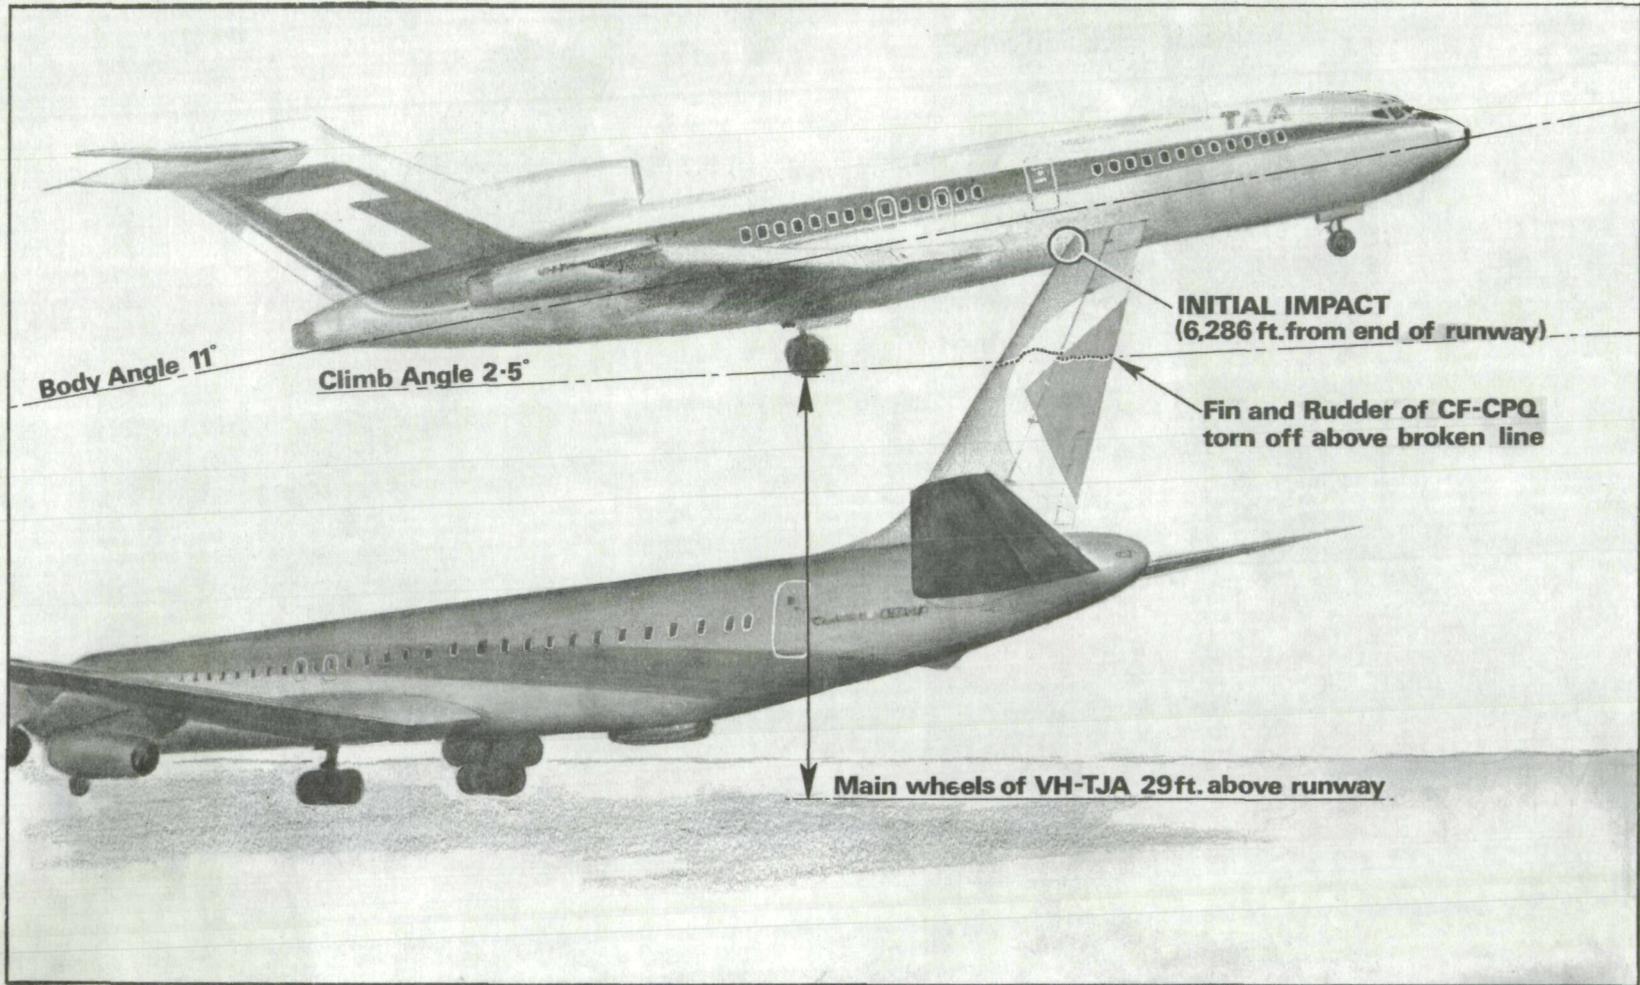
Having regard to the nature and extent of damage to both aircraft, it is also possible to reconstruct their height relationship at the time of impact. It is apparent that, at this time, the body angle of VH-TJA was approximately 11 degrees above the horizontal making due allowance for a climb gradient of approximately 2½ degrees, which is what is to be expected in the circumstances and is reflected in the flight data record. The flight crew of VH-TJA did not retract the undercarriage during this take-off. It is estimated that the clearance between the lowest portion of the main gear of VH-TJA and the top of the fuselage of CF-CPQ at the time of impact was of the order of nine feet (see Appendix E).

Relative positions of CF-CPQ and VH-TJA at and immediately after impact.
