ACCIDENT INVESTIGATION REPORT

Air Safety Investigation Branch

**Fokker Friendship F-27-100  
Aircraft VH-EWL,  
at Bathurst,  
New South Wales,  
on 31 May 1974**

Special Investigation Report 76-2

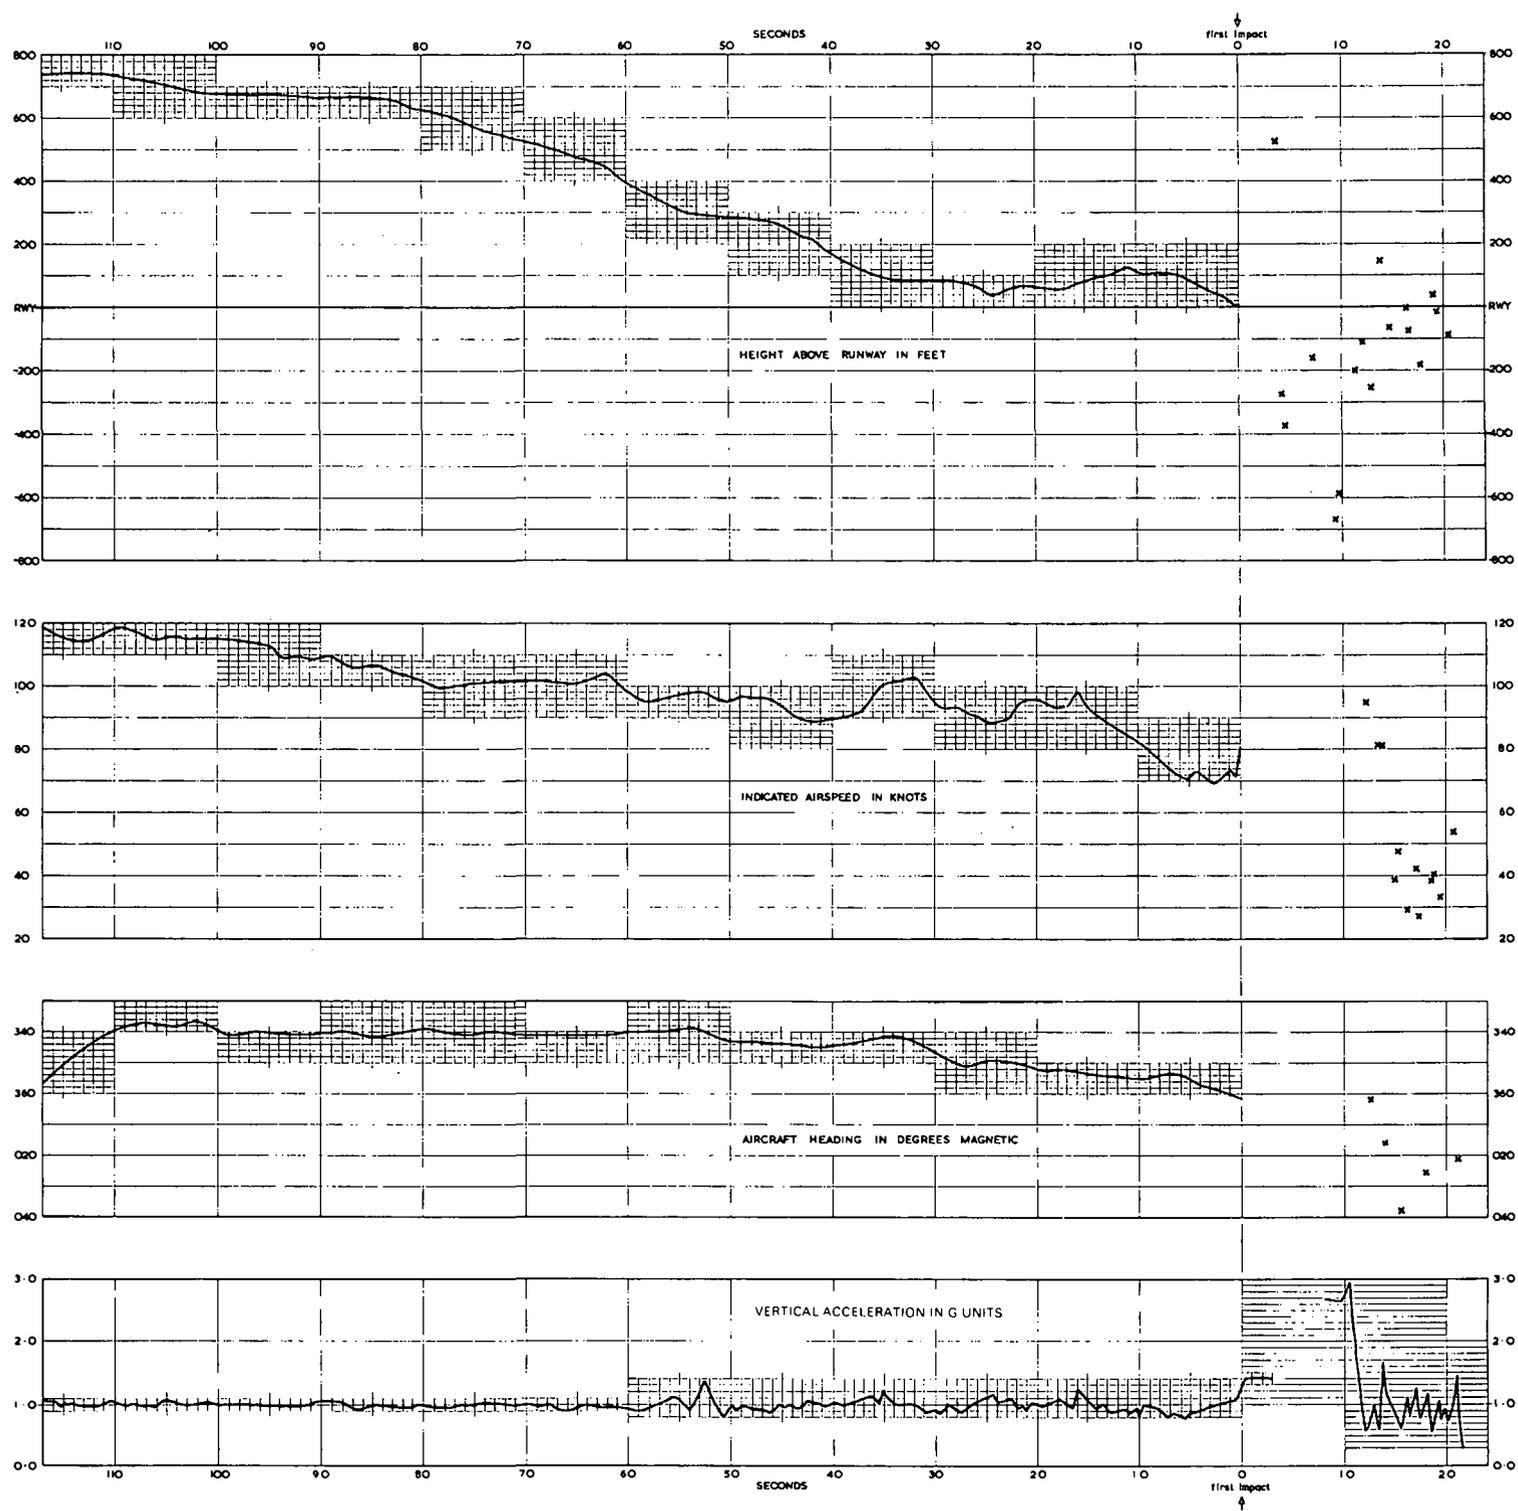
## REPRESENTATION OF THE FLIGHT DATA RECORD

It is significant that the traces indicate that, initially, the aircraft heading was consistent with the runway heading, and that the descent and airspeed pattern were normal. In respect of the vertical acceleration trace, a characteristic long-term excursion consistent with a turbulence encounter occurred 52.5 seconds before impact, and this was followed by a change of aircraft heading of some 4 degrees to the right. Turbulence then continued for the remainder of the flight. The recording indicates that the descent of the aircraft continued in a normal manner until 34 seconds before impact at which time the descent was arrested and a further change of aircraft heading of 8 to 10 degrees to the right occurred. At 24 seconds before impact the altitude trace exhibits a 'dip' characteristic of that associated with rotation of F-27 aircraft during a landing or take-off. During the next 8 seconds the indicated airspeed increased slightly as did the altitude, the indicated airspeed then decreased steadily from a peak of 99 knots to 70.5 knots and the aircraft gradually descended. The indicated airspeed fluctuated about 71 knots for 4.5 seconds then rapidly increased during 0.5 seconds at which time the impact with the ground occurred.

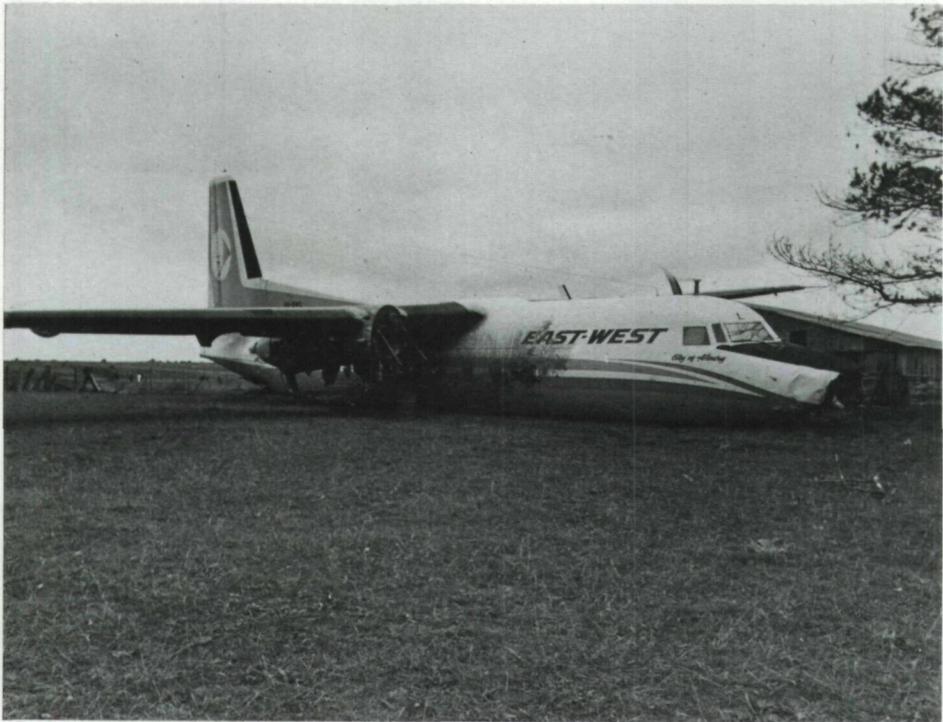
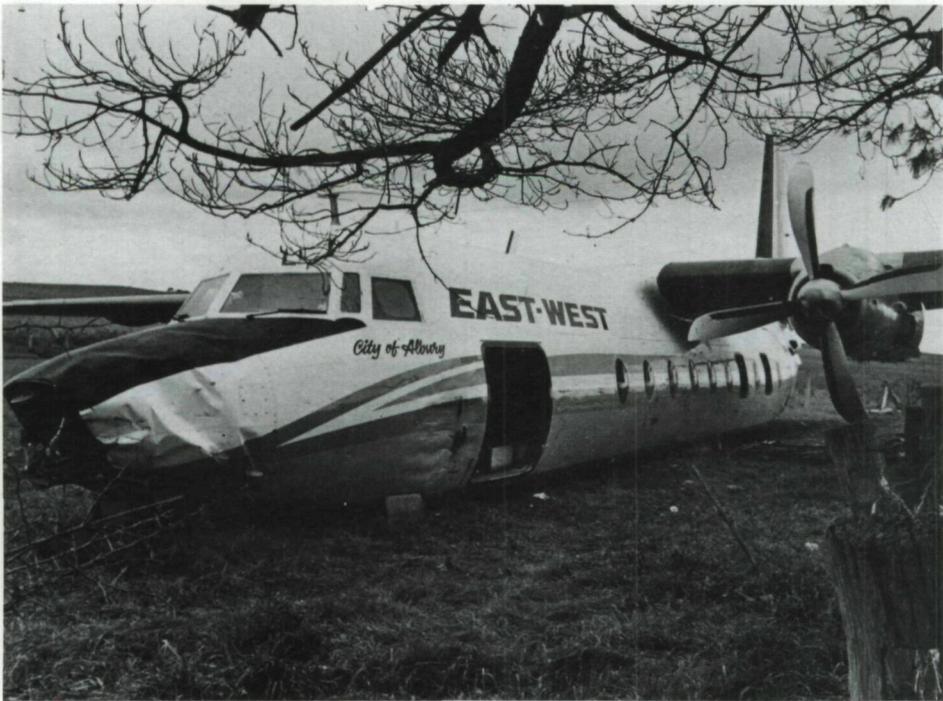
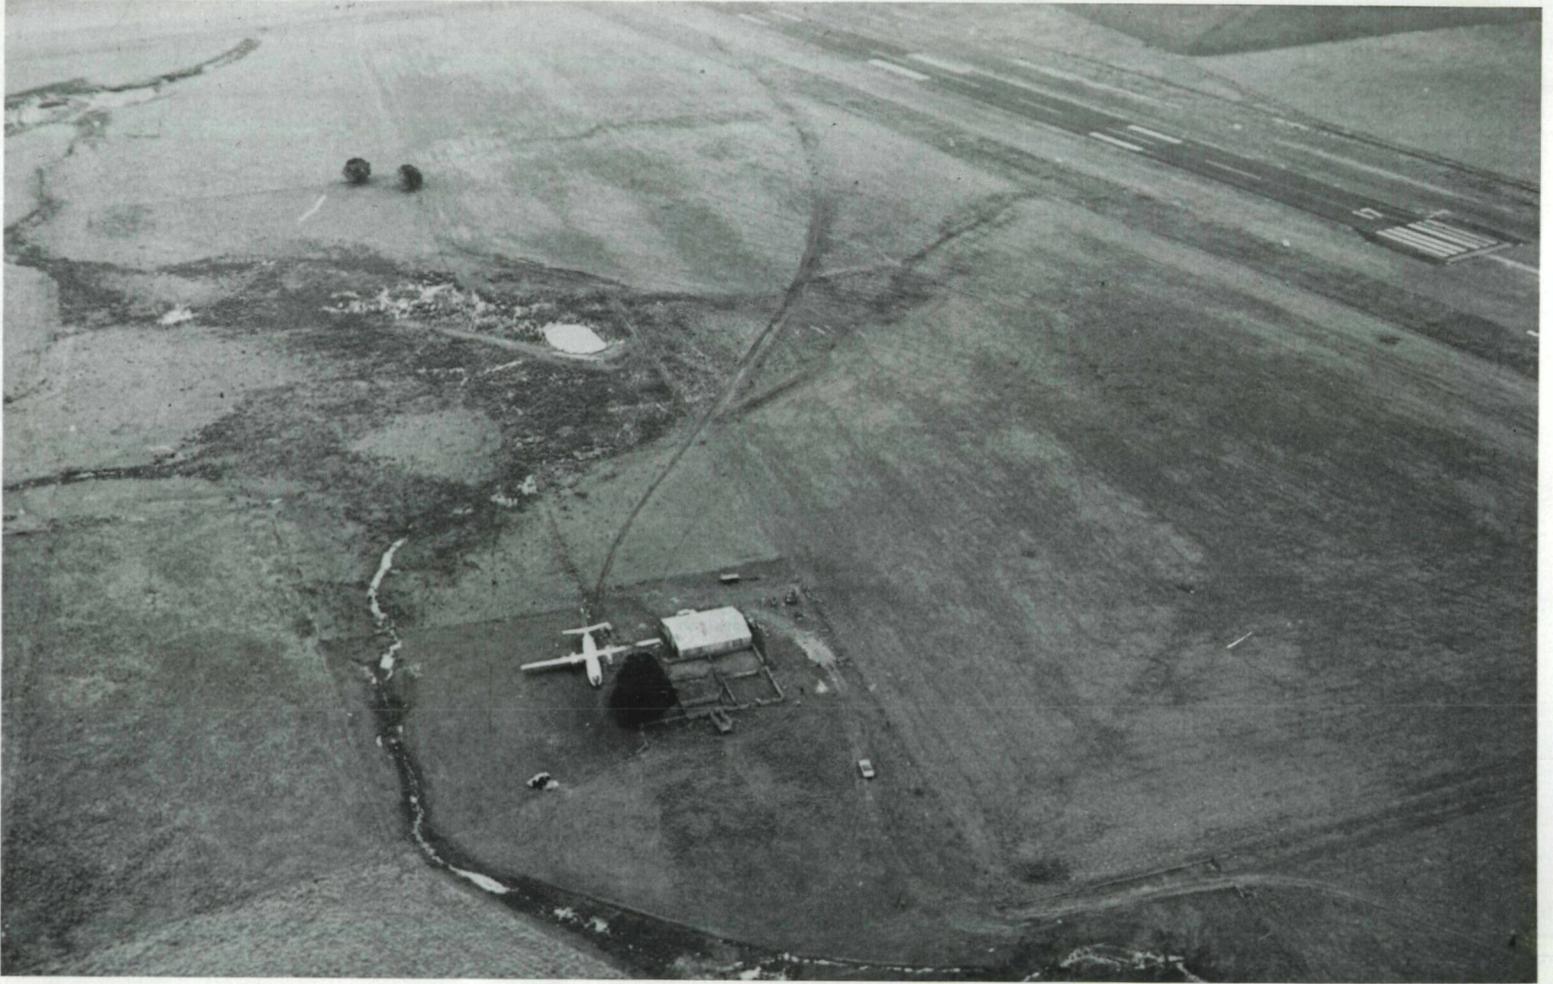
APPENDIX C

ground for a distance of 625 metres. The ground marks indicated that at initial impact the aircraft was tracking 356 degrees magnetic, 12.5 degrees to the right of the runway heading; and abrasion marks on the aircraft fuselage, consistent with the initial impact, indicate that the aircraft heading was 011 degrees magnetic, 27.5 degrees to the right of the runway heading. The initial ground impact damage incurred by the aircraft fuselage indicated that the probable body pitch angle at that time was between 6 and 8 degrees nose-up; and examination of the ground marks suggest that at first impact the aircraft was substantially laterally level, but possibly slightly right wing down.

Structural damage to the fuselage was confined generally to the lower fuselage area, but there was some distortion of the fuselage structure caused by impact loads. Additional damage to the nose section, and to the fuselage sides above the floor line, was caused by contact with fencing through which the aircraft passed.
