Report 09-004

Britten Norman BN2A-Mk III Trislander

ZK-LOU

loss of engine propeller assembly

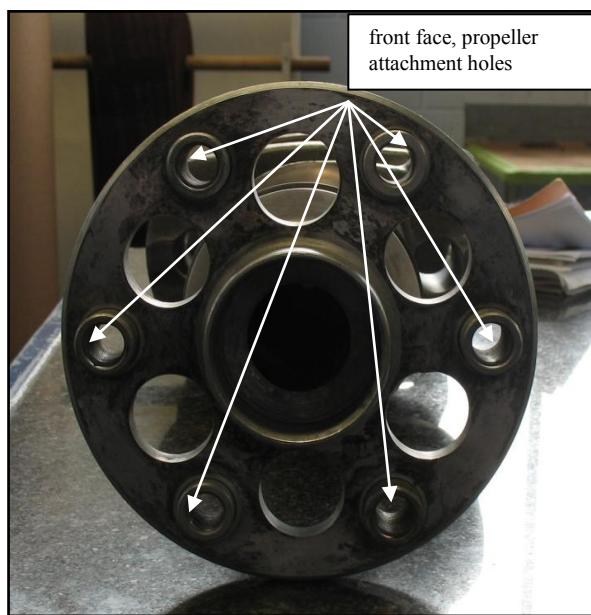
Figure 4
A serviceable crankshaft flange with lightening holes

The crankshaft had an end flange that contained 6 lightening holes separated by web spokes [see Figure 4]. The crankshaft also had a pair of counterweights at the rear to act as vibration dampers.
